# Re-attachment and monitoring of broken fragments of *Acropora palmata* following a ship grounding in Puerto Rico

South-east coast of Mona Island, Puerto Rico, USA – 1997-2008

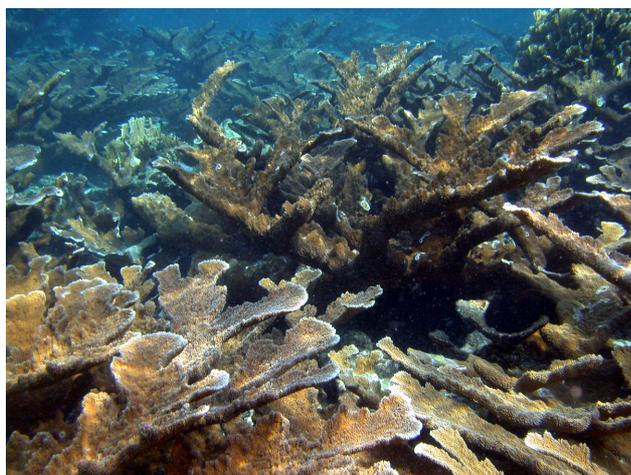
**Figure 1:** *Acropora palmata* stand adjacent to the *Fortuna Reefer* grounding site in 1997 (Photo: A. Bruckner).

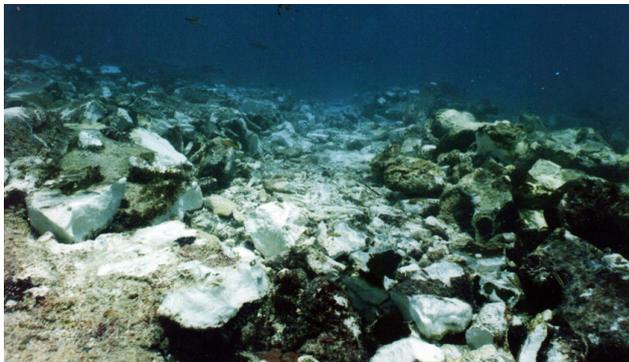
**Figure 3:** *Fortuna Reefer* site one week after the grounding in 1997 showing where the keel struck the reef (Photo: J. Morlock).

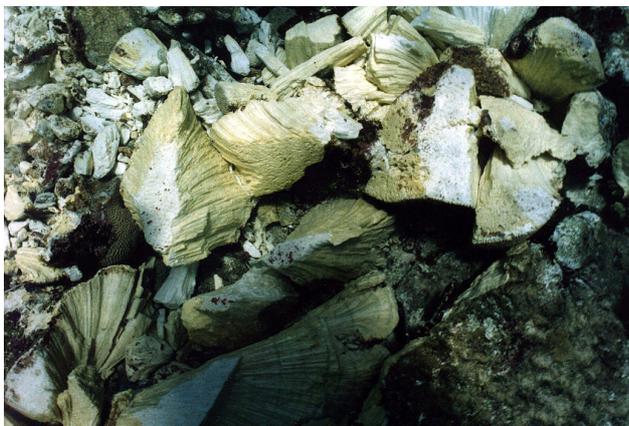
**Figure 4:** Reef framework and large *Diploria strigosa* colonies crushed by the impact of the *Fortuna Reefer* (Photo: A. Bruckner).

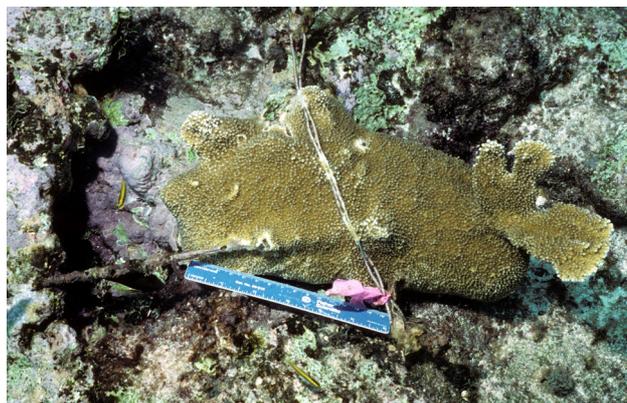
After 3 years (i.e. by 2000), a further 8.3% of fragments had disappeared from the site, making a total of 25% loss of reattached fragments as a result of wire corrosion and breakage. The wire was also a significant cause of partial mortality, as the high surge at the shallow site loosened it and then abraded coral tissue that was in contact with it. However, there were some instances where the tissue overgrew the wire where it remained tight. Algae or *Millepora* also overgrew the wire dividing tissue into smaller patches that slowly died. The fragments exhibited a limited ability to fuse to the substrate and only about 17% of the survivors at 3 years showed tissue growth onto the substrate.

**Figure 5:** Approximately 60 cm long fragment of Elkhorn coral, *Acropora palmata*, broken off during the grounding which has been secured to nails in the reef with stainless steel wire during the restoration. Both original wire (overgrown) and new wire added during mid-course correction are visible (Photo: A. Bruckner).

Due to considerable corrosion and breakage of the original wires after about 3 years, surviving fragments were further stabilized (Figure 5) in July 2000 using a more durable copper-nickel alloy wire (Monel 400) with, in some cases, Portland cement, particularly where fragments were located shallow, in heavy surge.

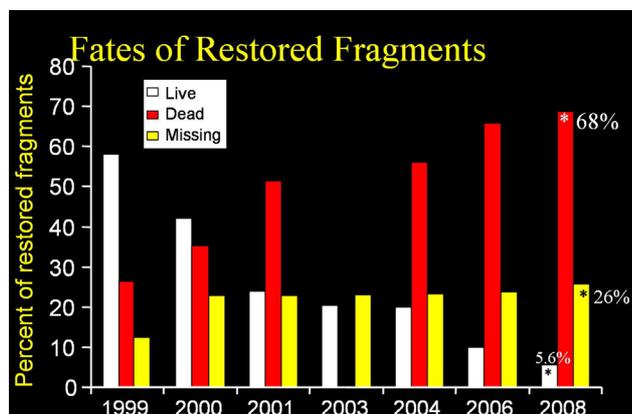
After 10 years (2008), just under 6% (104) of the fragments were still alive, although only a small proportion of these were securely fused to their attachment sites; 26% had become detached or were missing, and 68% had died in place (Figure 6). About half of the survivors resembled adult colonies with tissue covering the upper skeletal surfaces, extensive branching (mean = 5 branches, 89 cm in length), and a substantial increase in height (mean 39 cm tall). The highest survival was in fragments of 20–80 cm length attached to the relict

**Figure 6:** Fates of attached *Acropora palmata* fragments between 1999 and 2008 (Bruckner et al. 2009).
